Status Investigation Report of A
Self-Contained Breathing Apparatus
Submitted by the
Baltimore County Fire Department and Police Department
for the
Lutherville, MD Fire Department,
Lutherville, MD

NIOSH Task Number 17689

April 18, 2011

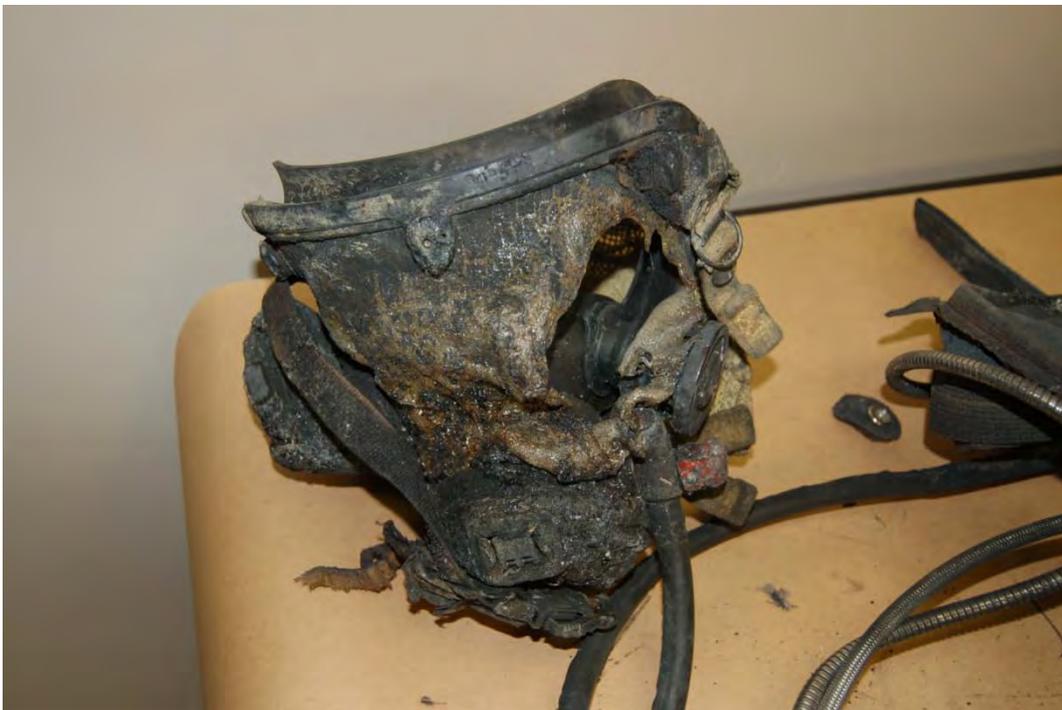
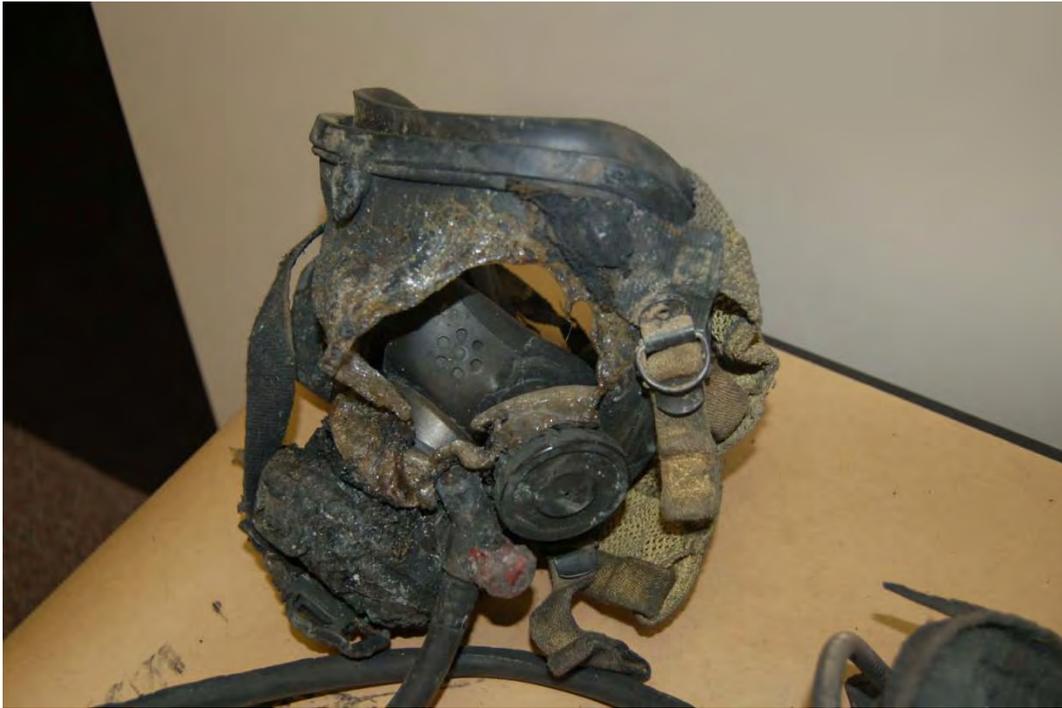
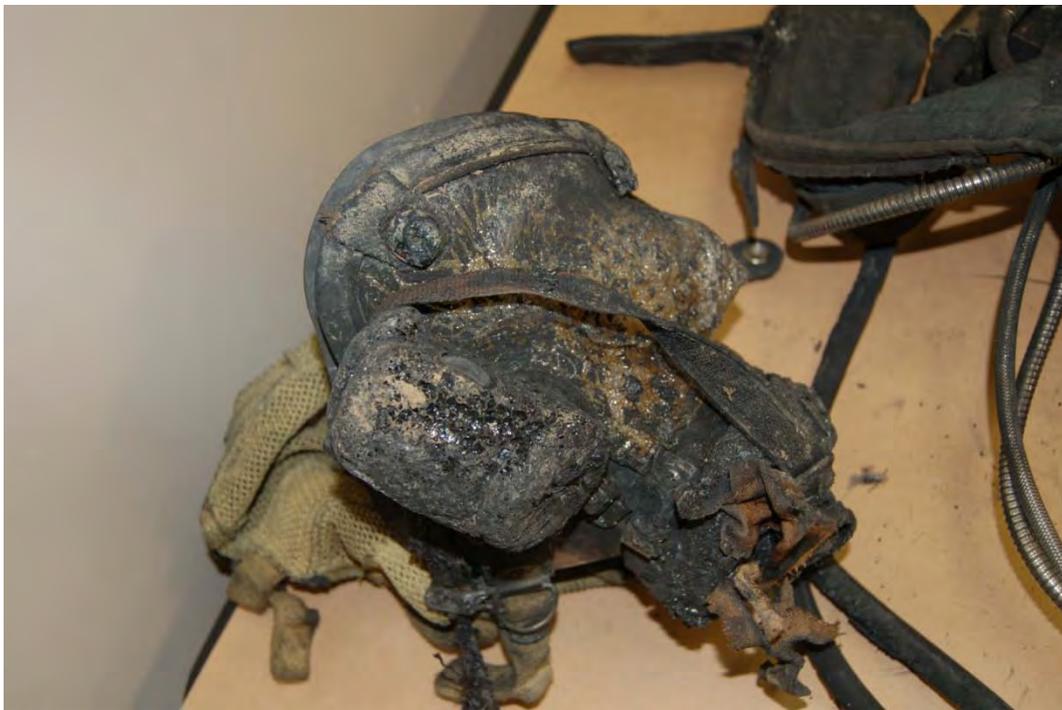
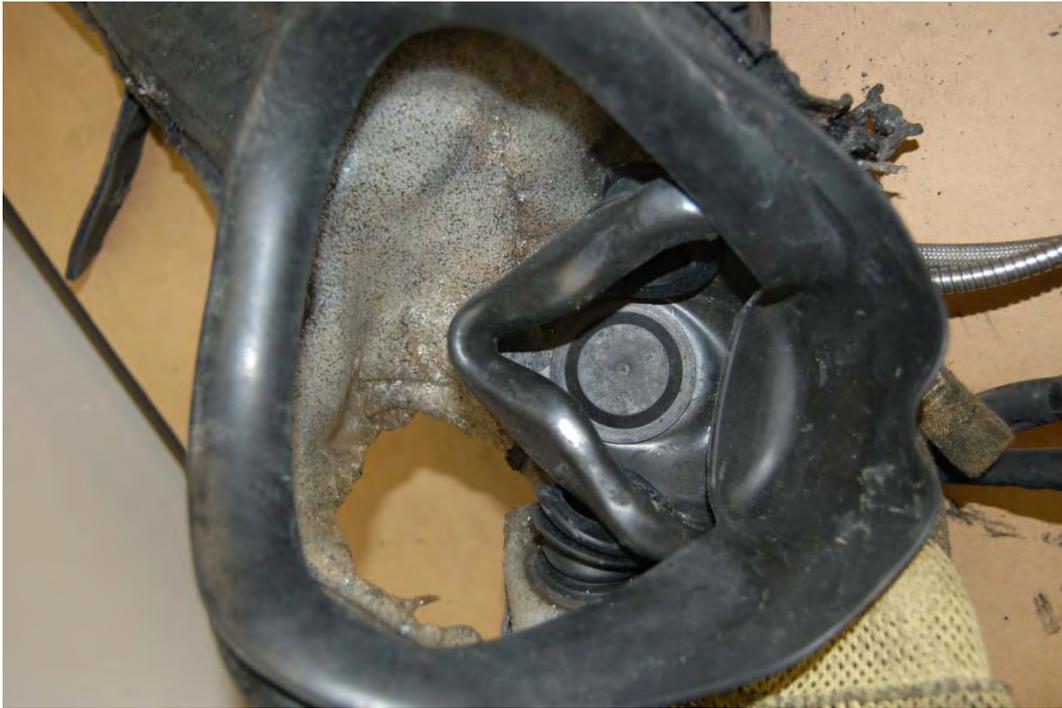
- As received, the regulator assembly was attached to the facepiece and severely damaged as the plastic materials had been melted. The mask mounted regulator was unrecognizable and was permanently attached to the facepiece due to the plastic regulator housing having melted and bonded to the facepiece plastic component housing that had also melted.
- The lens was extensively damaged, melted, bubbled and a hole, pushed outward, was present on the left side.
- No visibility was present through the lens.
- All facepiece plastic components had all been melted except the lens rings.
- The rubber face seal material was deformed.

- The left temple strap was no longer attached to the facepiece as the attachment was ripped.
- The nose cup was in fair condition with foreign matter present on the inside.
- The nose cup was dislodged from the voice/radio interface port.
- The nose cup inhalation valves were present and in fair condition.
- The voice projection unit, on the right side of the facepiece was heavily damaged and the housing was melted.
- The radio interface bracket, on the left side of the facepiece was present.

Figure 8 - Unit #1 Facepiece with Regulator

Figure 9 – Unit #1 Facepiece with Lens Damage

Figure 10 – Unit #1 Facepiece with Voice Projecting Unit

Figure 11 – Unit #1 Inside View of Facepiece

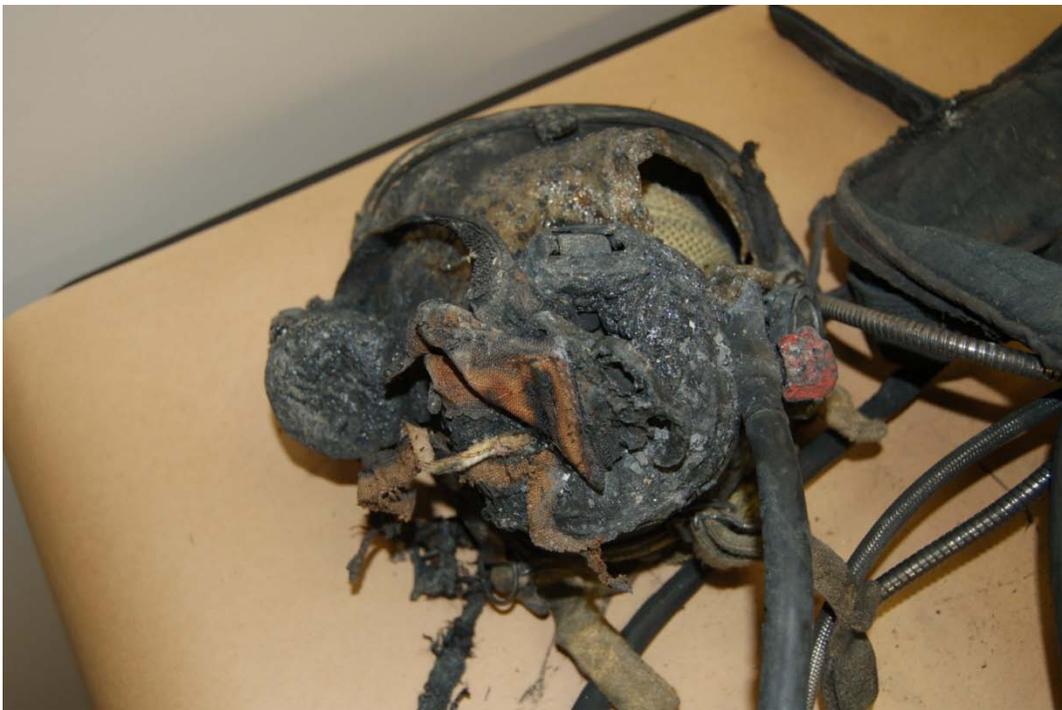
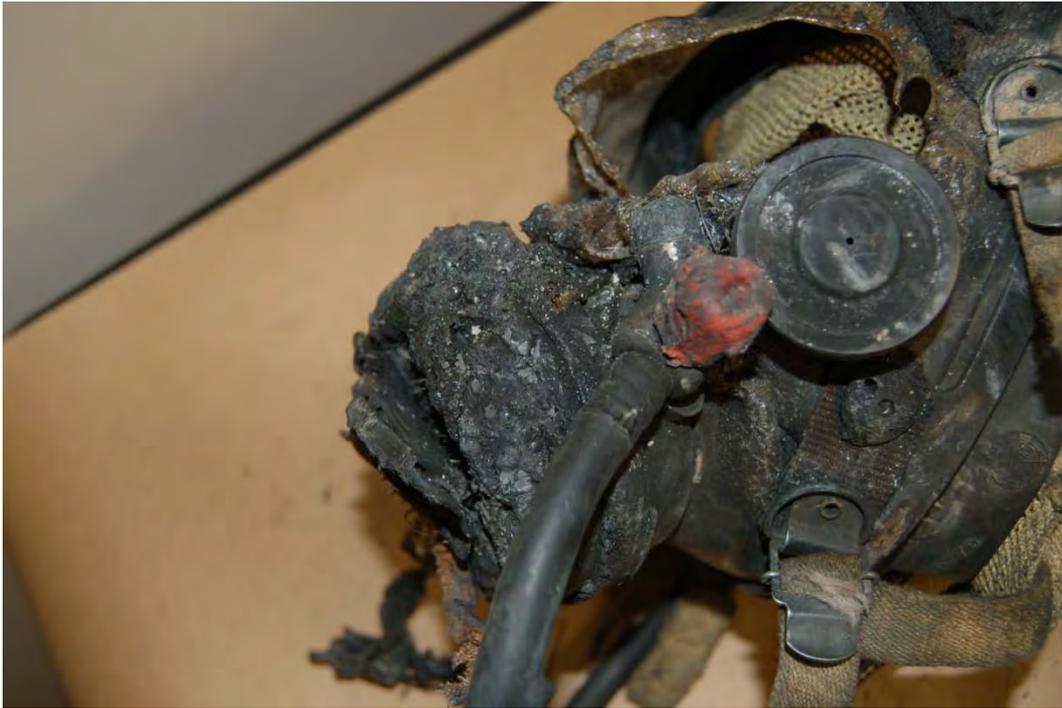
- As received, the regulator assembly was heavily damaged and attached to the facepiece. The regulator could not be removed as the plastic components had been melted and were permanently bonded to the facepiece.
- Internal components of the regulator were visible.
- None of the activation buttons were functional or recognizable.
- No visible part number.
- The by-pass valve was damaged, but was operable, found in the closed position, and the plastic activation button material was melted.
- The larger internal regulator valve spring was exposed.
- A Strap and adjuster were melted onto the regulator body.
- The low pressure hose was attached to the regulator.
- Donning switch cover was not present.

Figure 12 – Unit #1 Second Stage Regulator Assembly

Figure 13 – Unit #1 Regulator By-Pass Knob

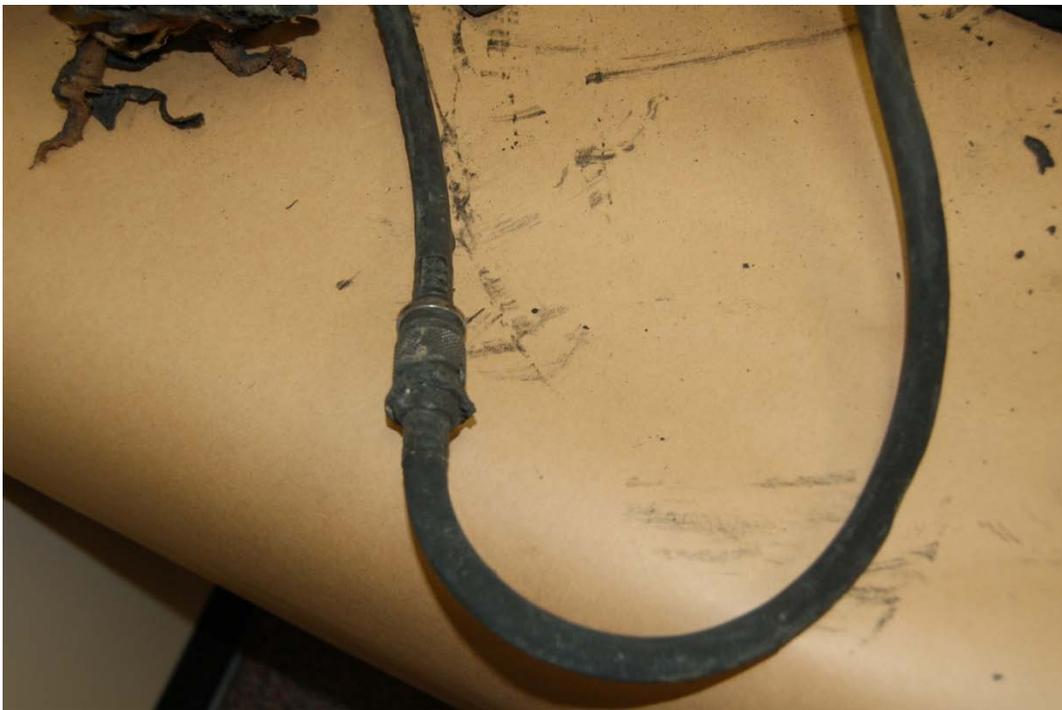
Figure 14 – Unit #1 Low Pressure Hose and Quick Disconnect

- No part number was visible.
- Over-all condition of the hose was extremely damaged.
- The outside cover of the hose was burned the entire length.
- Unable to dis-engage the quick disconnect.
- Both ends of the hose were attached as assembled.

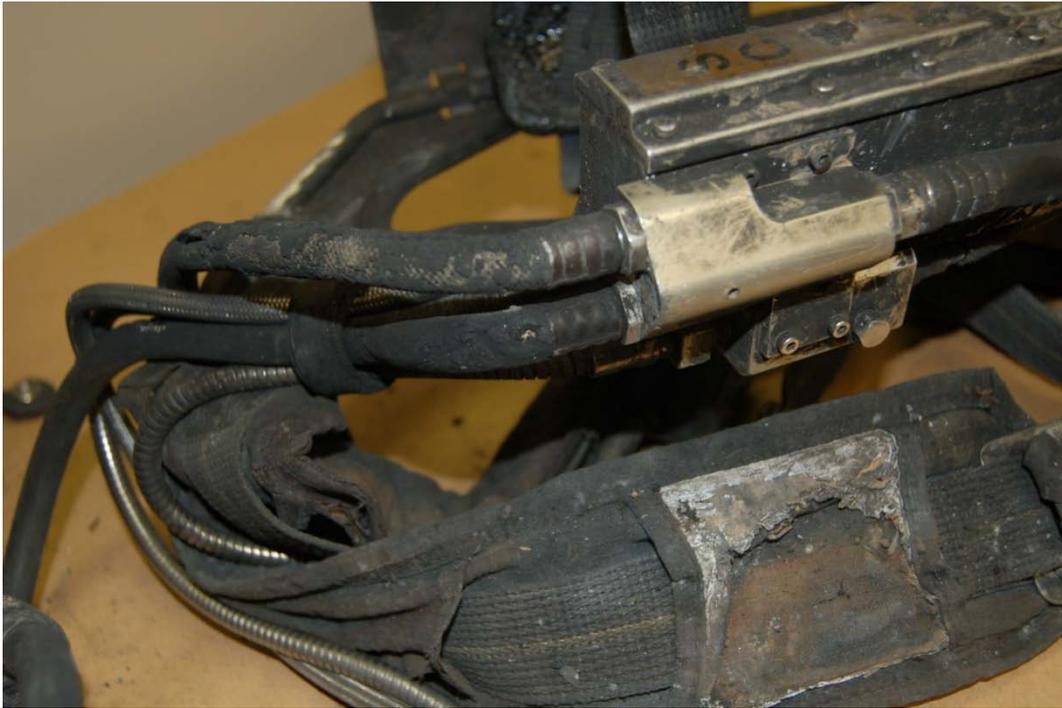
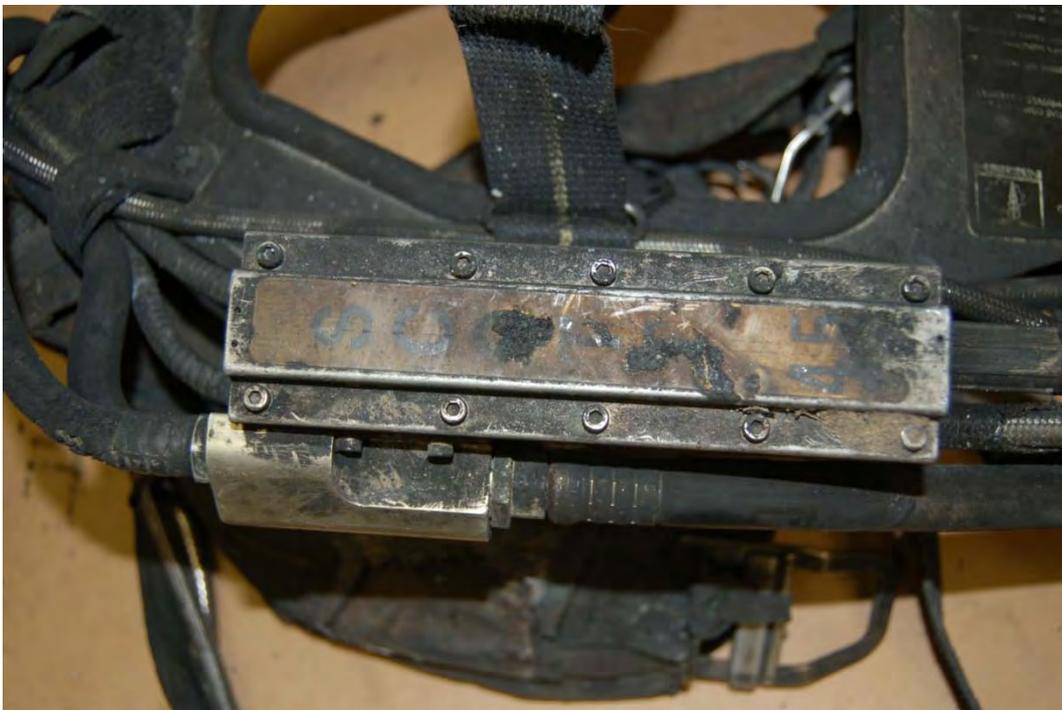
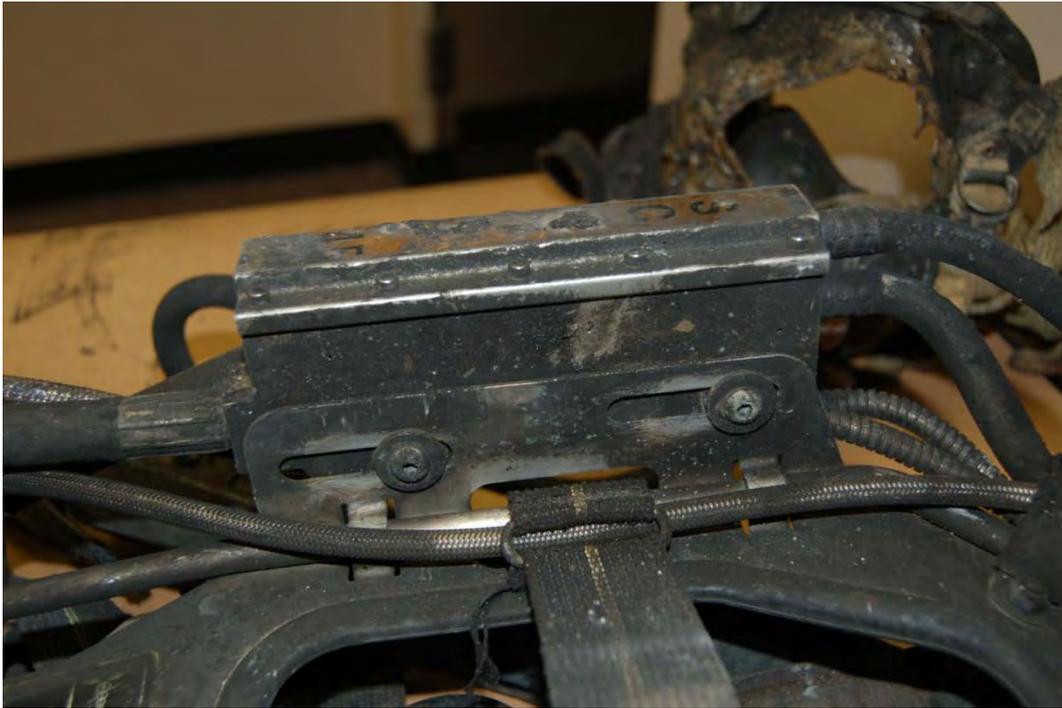
- No part number or serial number markings were visible.
- Very dirty on outside of the housing.
- Regulator was attached to the backframe and the regulator was able to be adjusted with the attachment bracket.
- All the hoses were connected properly to the regulator.

Figure 15 – Unit #1 Hose Connections to Pressure Reducer

Figure 16 – Unit #1 Pressure Reducer Assembly

Figure 17 – Unit #1 Pressure Reducer Assembly Mounted to Backframe

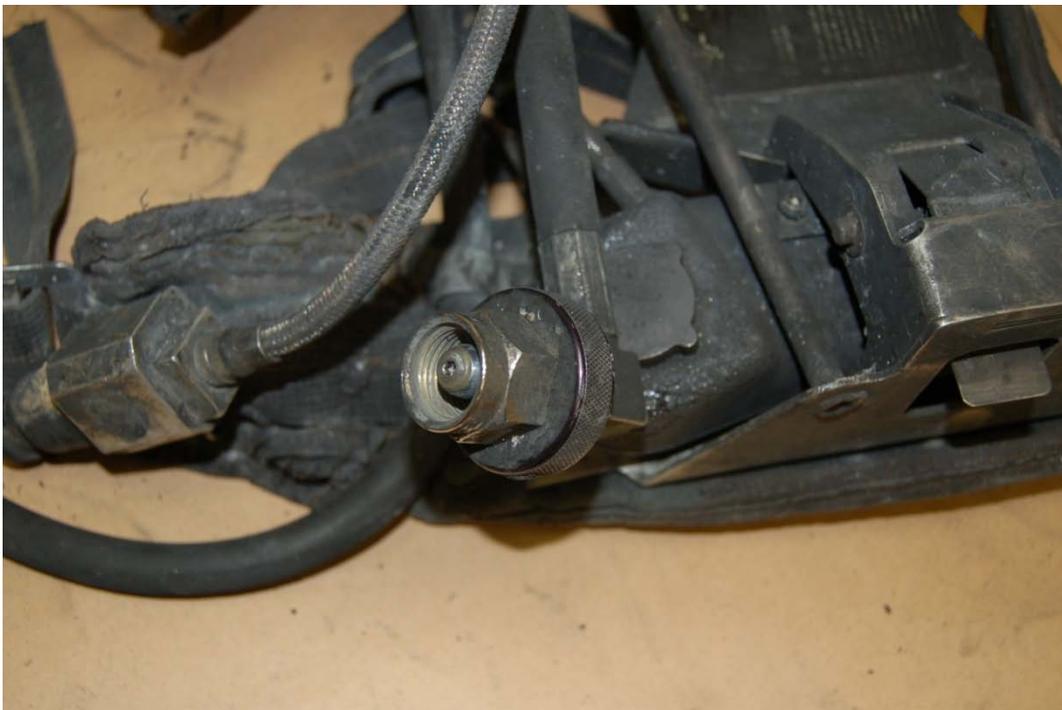
Figure 18 – Unit #1 High Pressure Hose and Cylinder Attachment Assembly

- The over-all condition of the assembly is extremely damaged.
- The high pressure hose line has been burned the entire length with some inner hose exposed.
- The cylinder attachment hand wheel can be turned.
- The attachment threads are fairly clean and threads on and off of the cylinder.
- The sealing o-ring is present and appears in good condition.

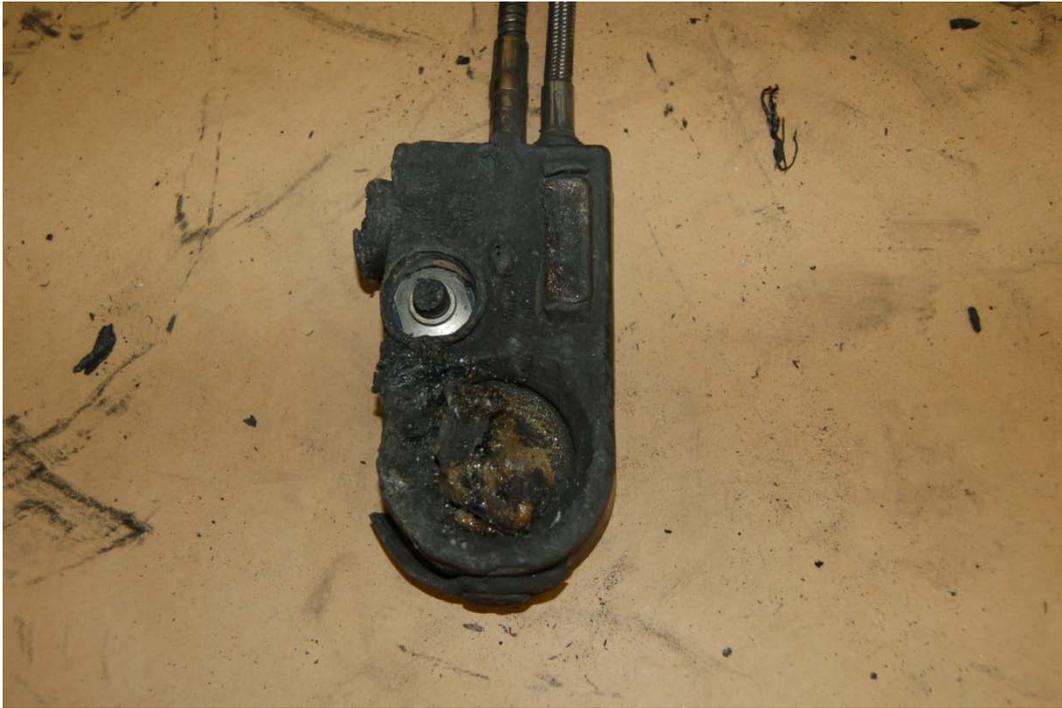
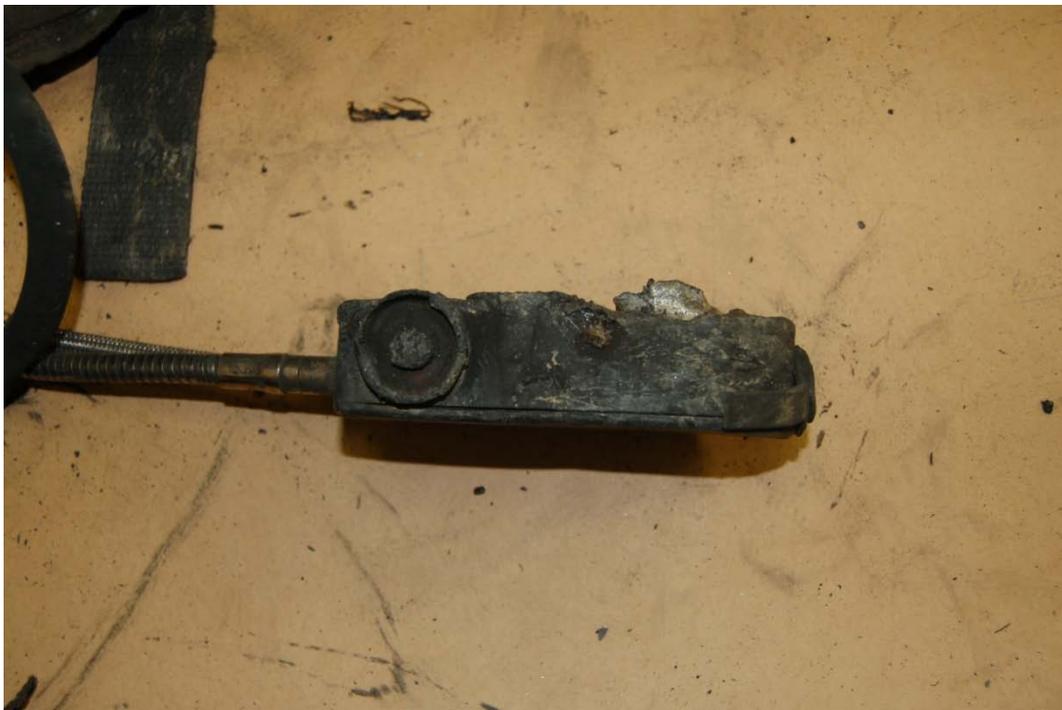
- S/N not visible.
- Manufacture date not visible.
- Condition of unit is extremely damaged.
- Gauge lens melted and gauge unreadable.
- Plastic housing damaged and melted at the unit top.
- Rubber attachment strap burned and in two pieces.
- PASS did not function when activated.
- PASS buttons appear to be functional.
- SEI PASS Label present; NFPA 1982: 1998 Edition.

Figure 19 – Unit #1 PASS Console with Remote Gauge

Figure 20 – Unit #1 PASS Console

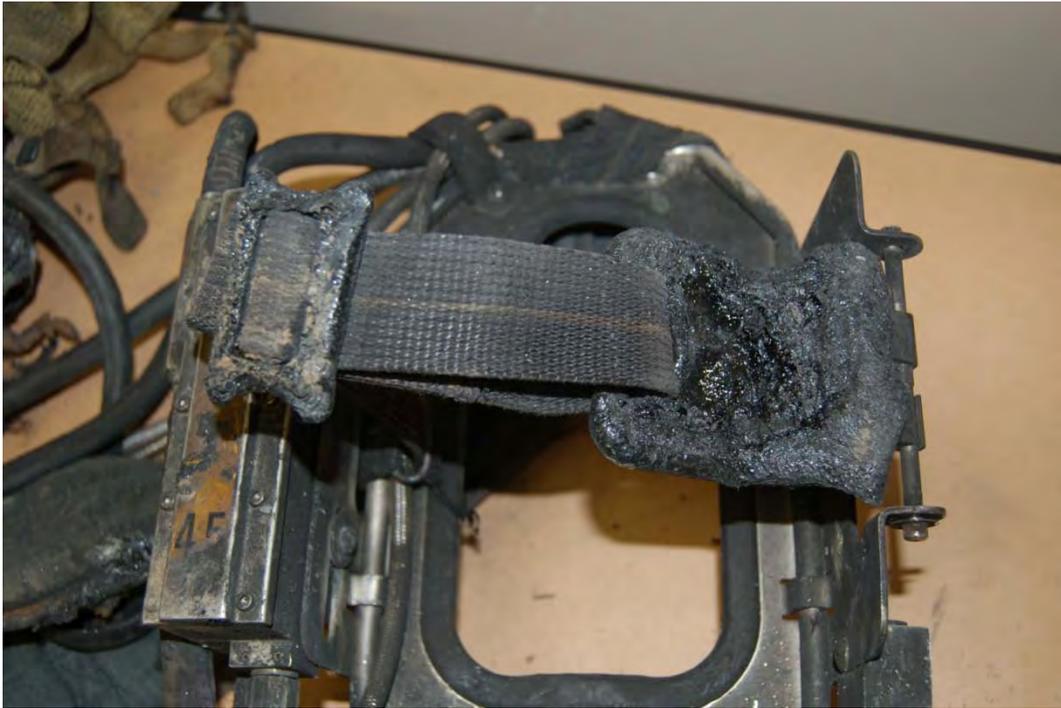
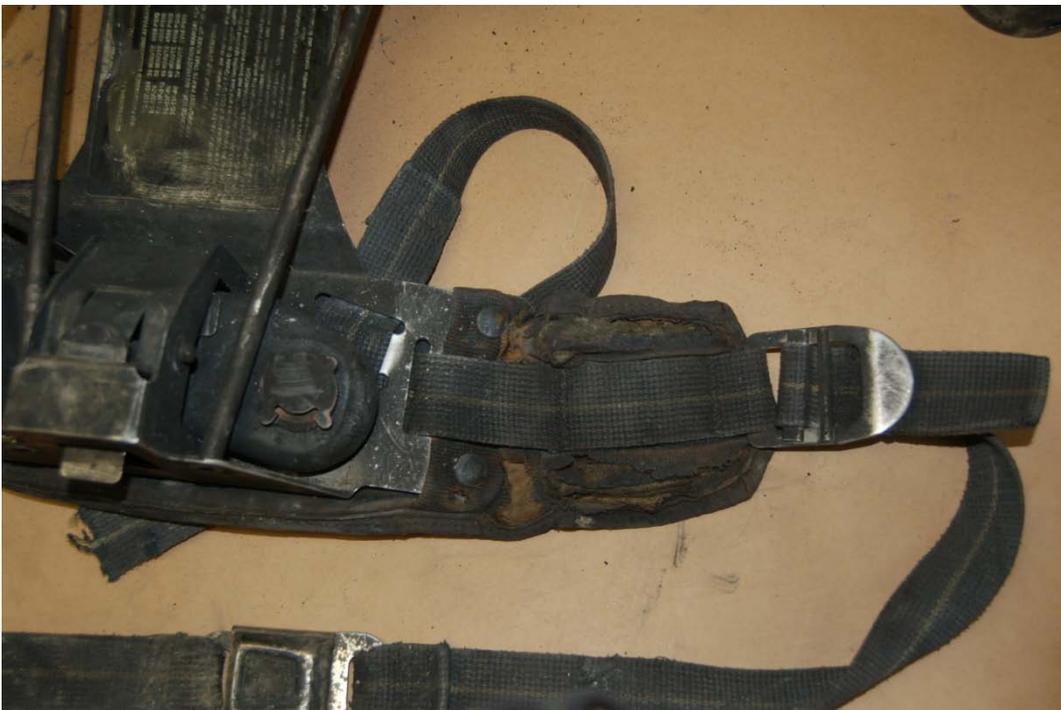
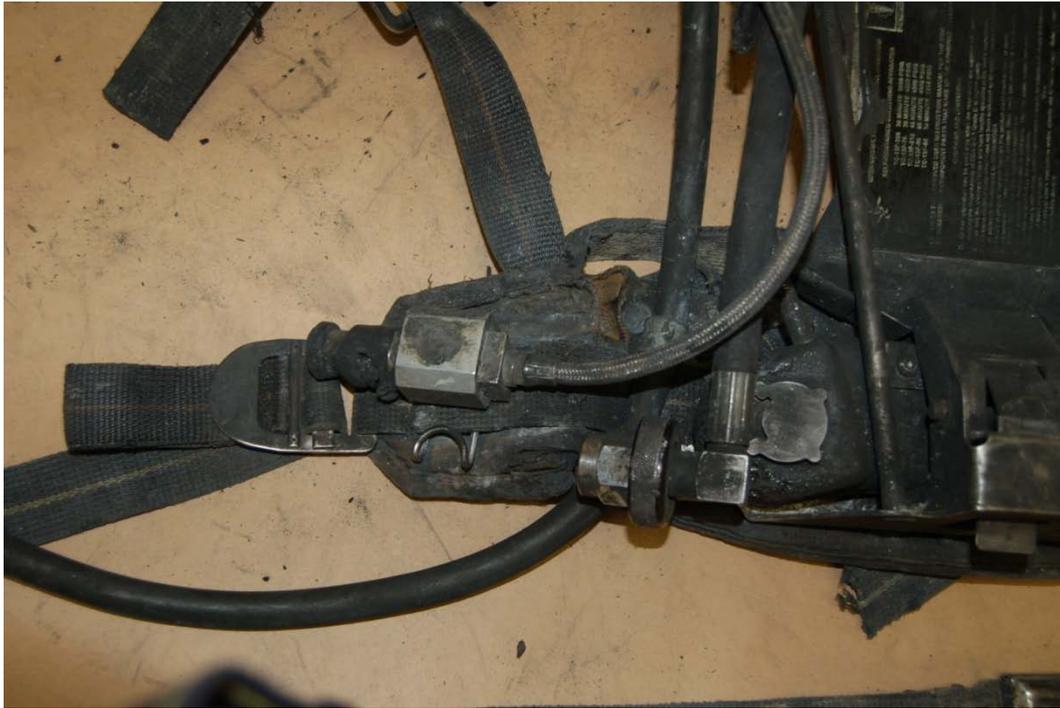
- Over-all condition of the backframe is fair.
- No bends or cracks present in the metal frame base.
- Shoulder straps are attached to the frame.
- Cylinder strap and latching handle are both extremely damaged.
- Cylinder strap adjuster is damaged but functional.
- Cylinder latching handle is damaged but can be moved.

Figure 23 – Unit #1 Backframe and Cylinder Strap Assembly

Figure 24 – Unit #1 Backframe and Lumbar Pad

Figure 25 – Unit #1 Backframe and Lumbar Pad with RIC Fitting

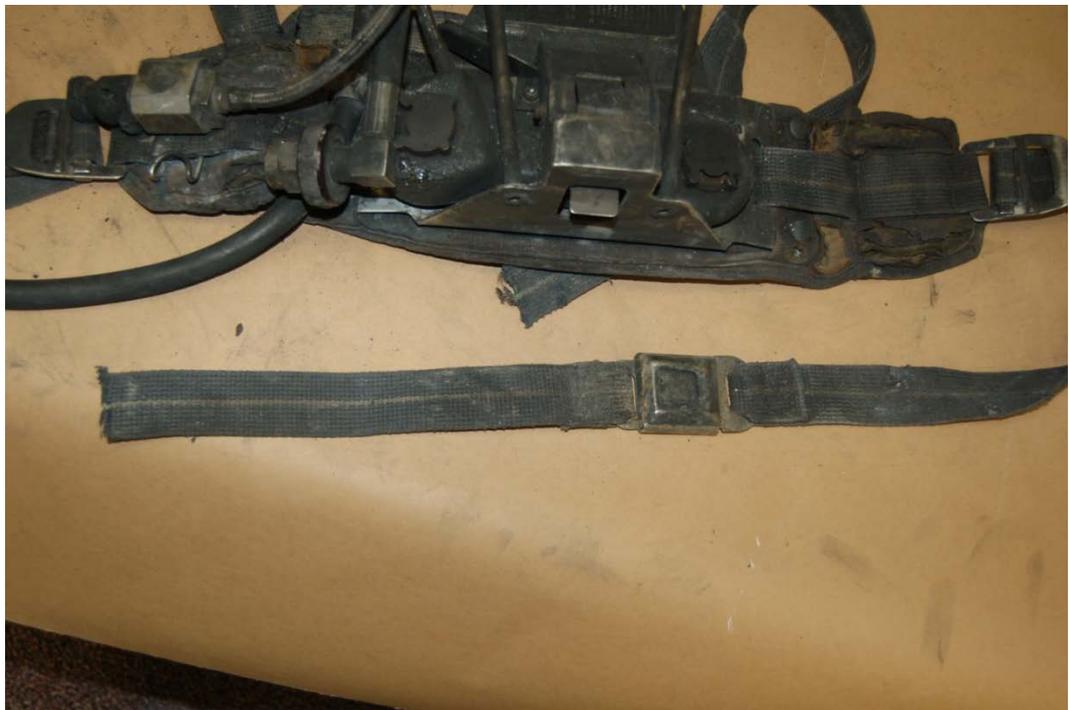
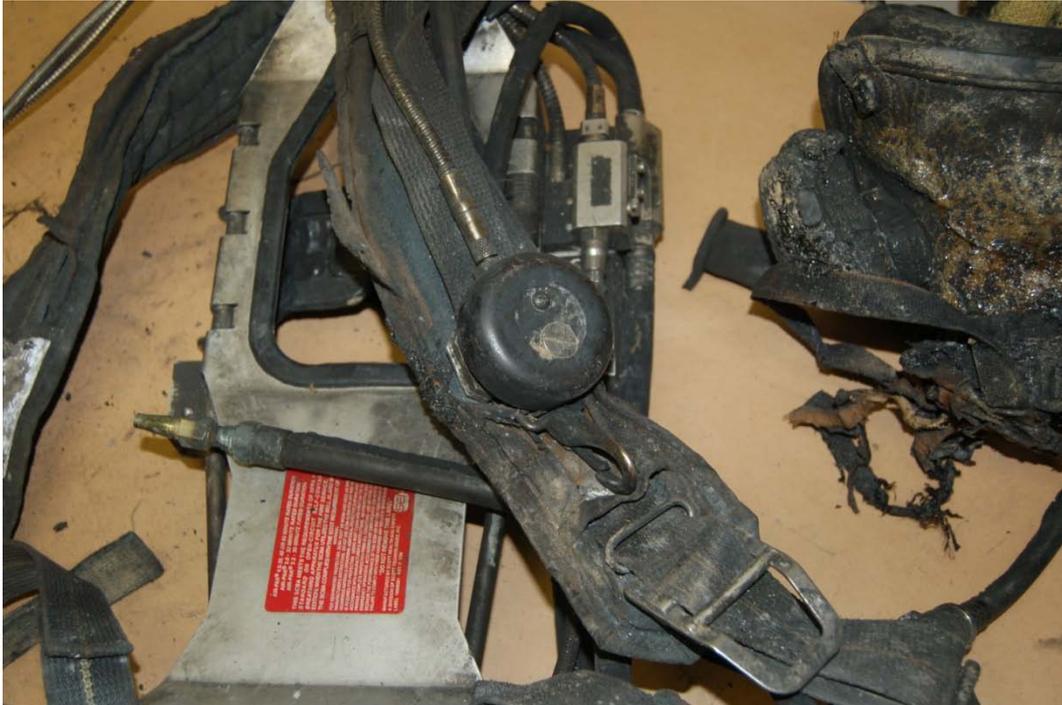
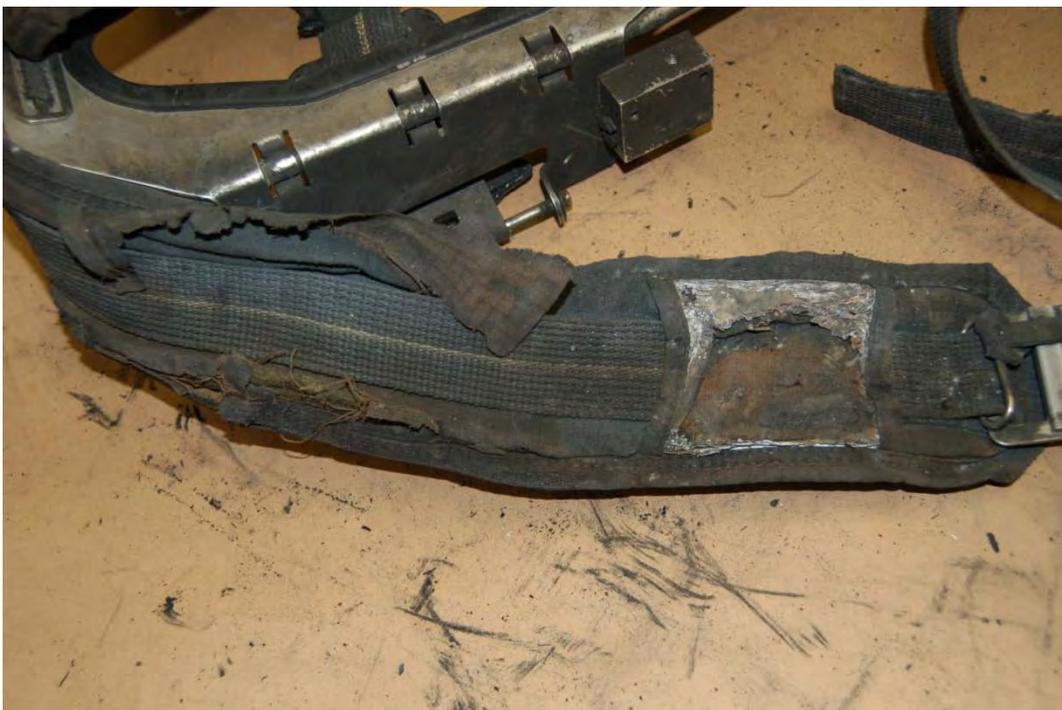
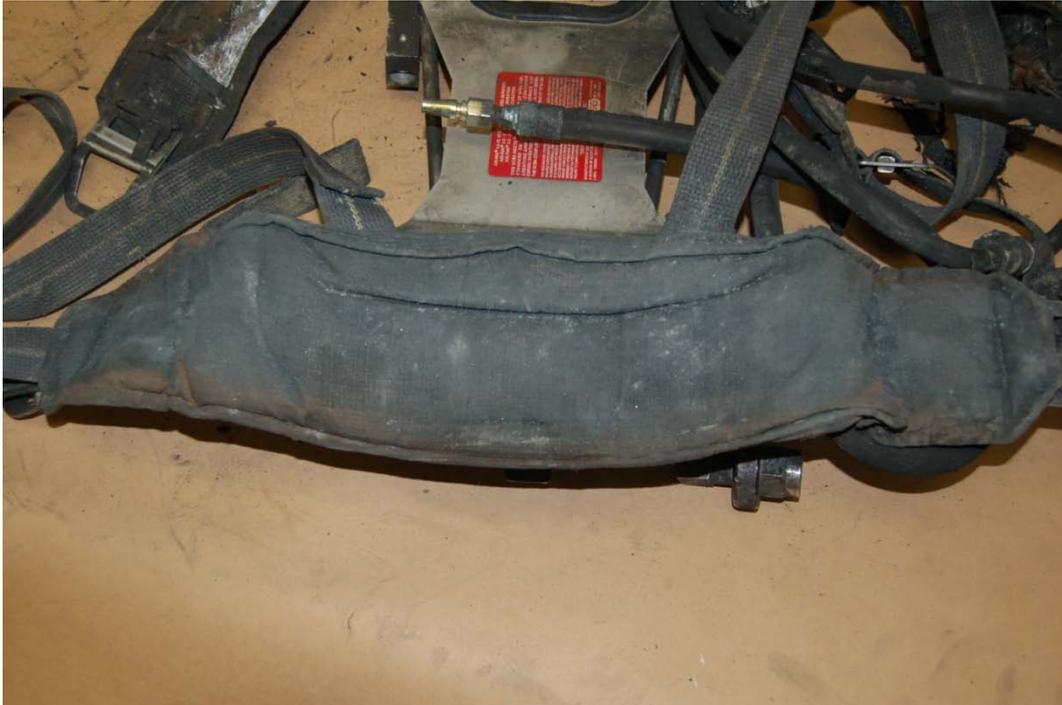
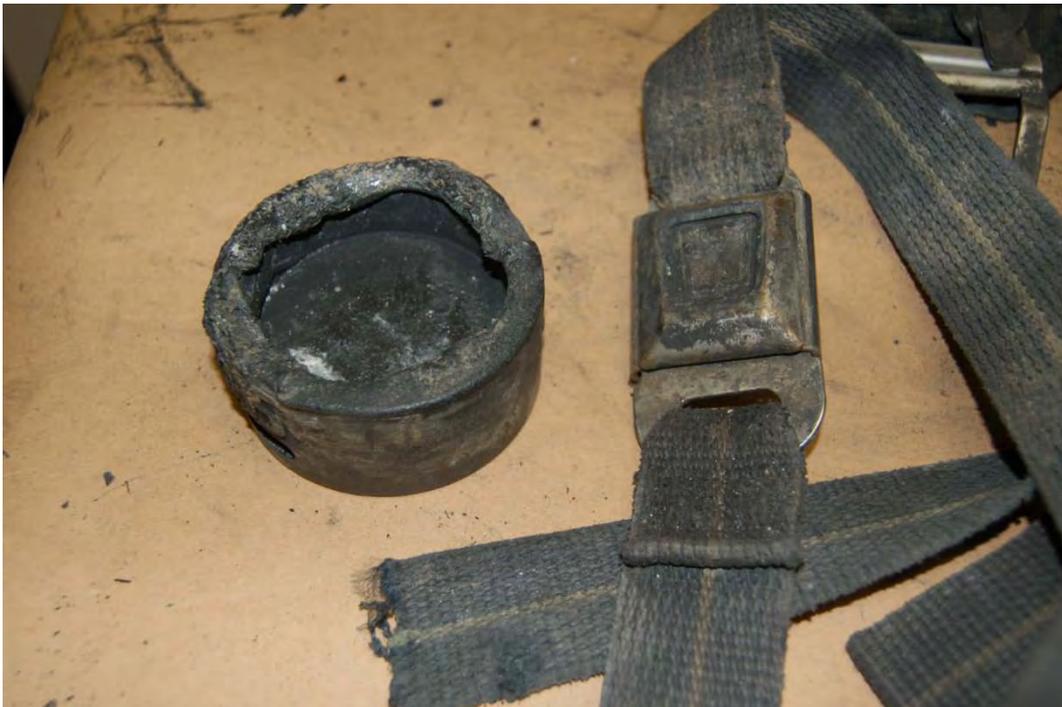
- The condition of the straps is extremely damaged.
- Shoulder straps are damaged and some of the inner material is exposed.
- Some of the outer shoulder strap material is missing.
- End of service life Bell Alarm is attached to the left shoulder strap.
- Alarm Hose attached at both ends.
- The waist strap has been cut in two.
- Waist buckle latches and releases.
- All adjustable buckles move and hold the straps in place.
- Mask mounted regular docking bracket loose and not assembled to waist belt.
- Docking bracket damaged.

Figure 28 – Unit #1 Waist Strap and Buckle

Figure 29 – Unit #1 Left Shoulder Strap with Bell Alarm Attached

Figure 30 – Unit #1 Right Shoulder Strap

Figure 31 – Unit #1 Lumbar Pad Inside

Figure 32 – Unit #1 Regulator Docking Bracket and Waist Strap

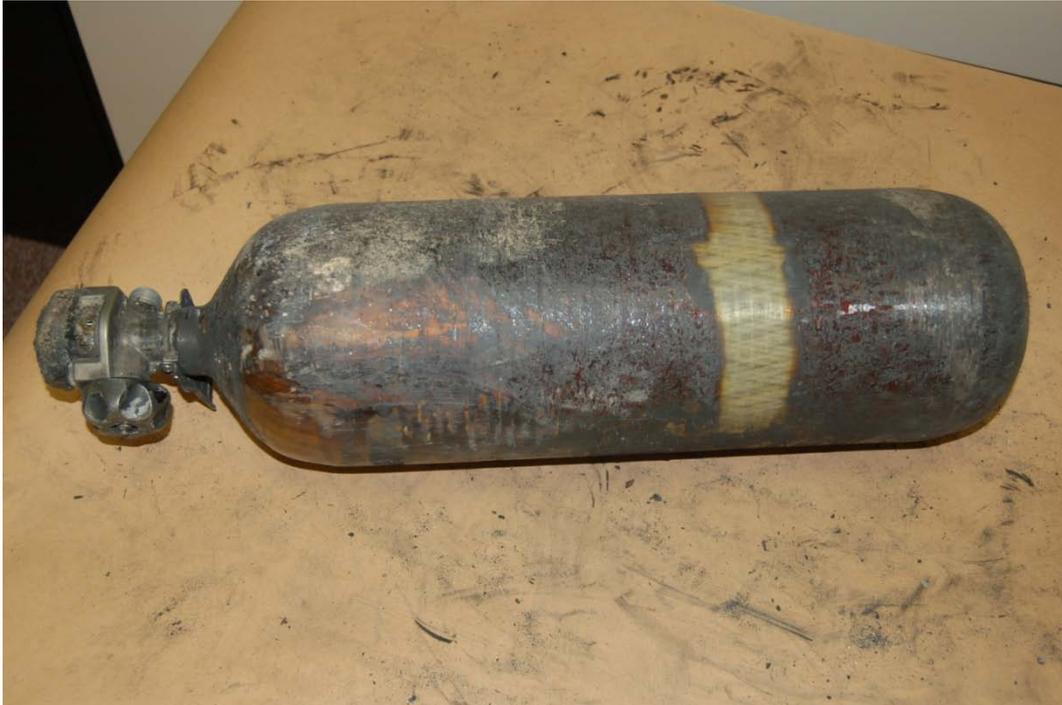
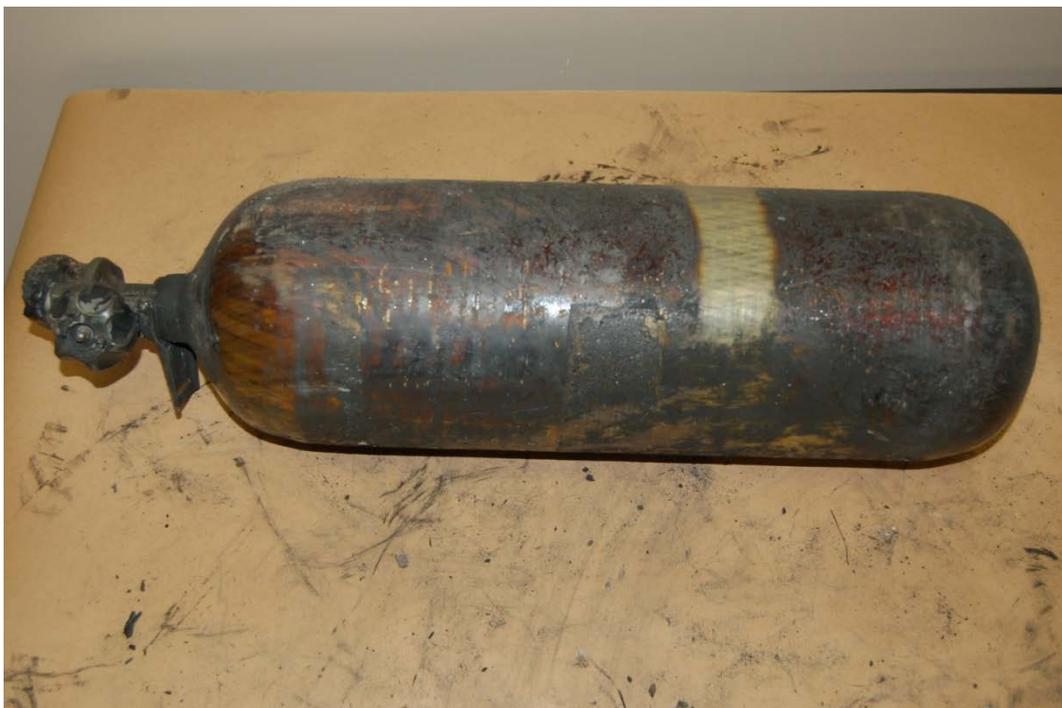
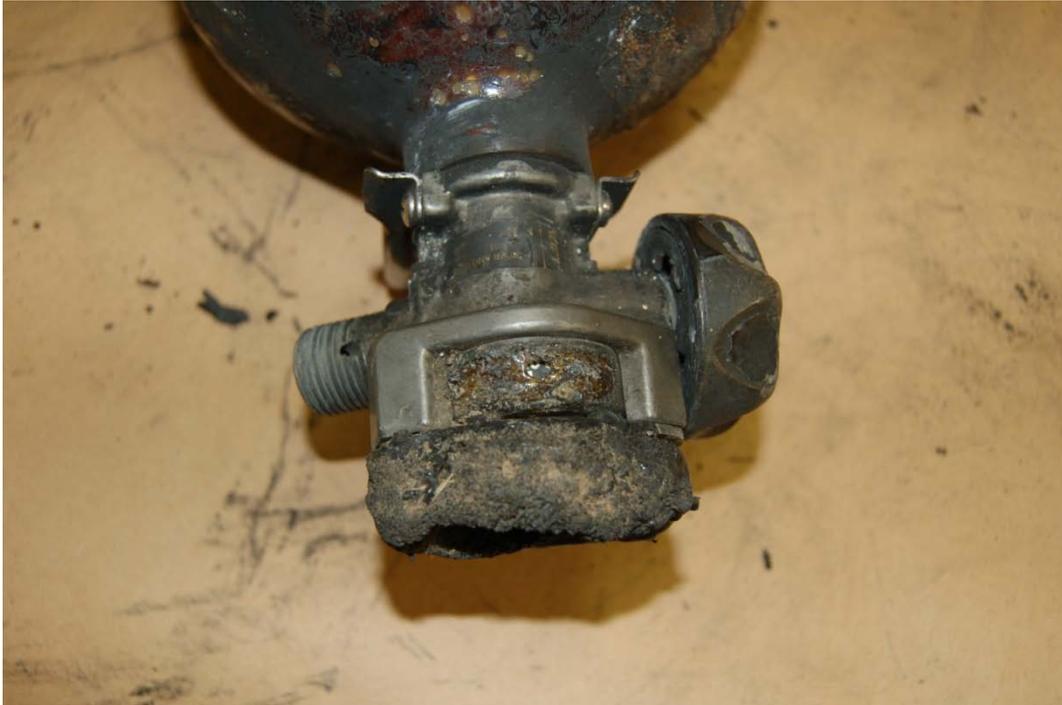
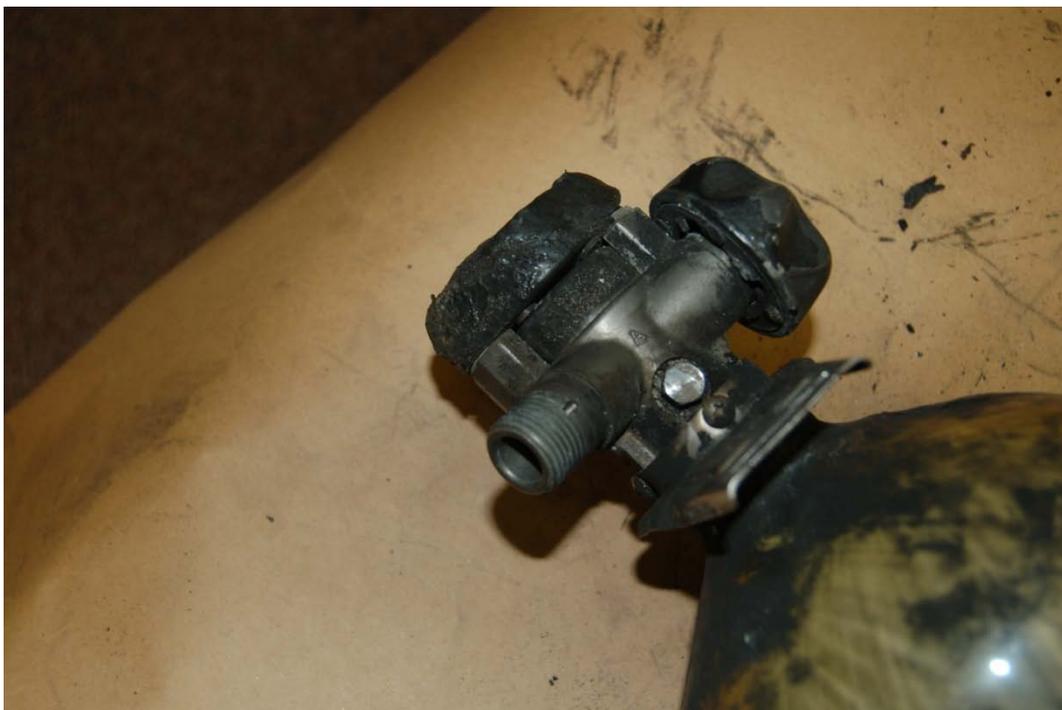
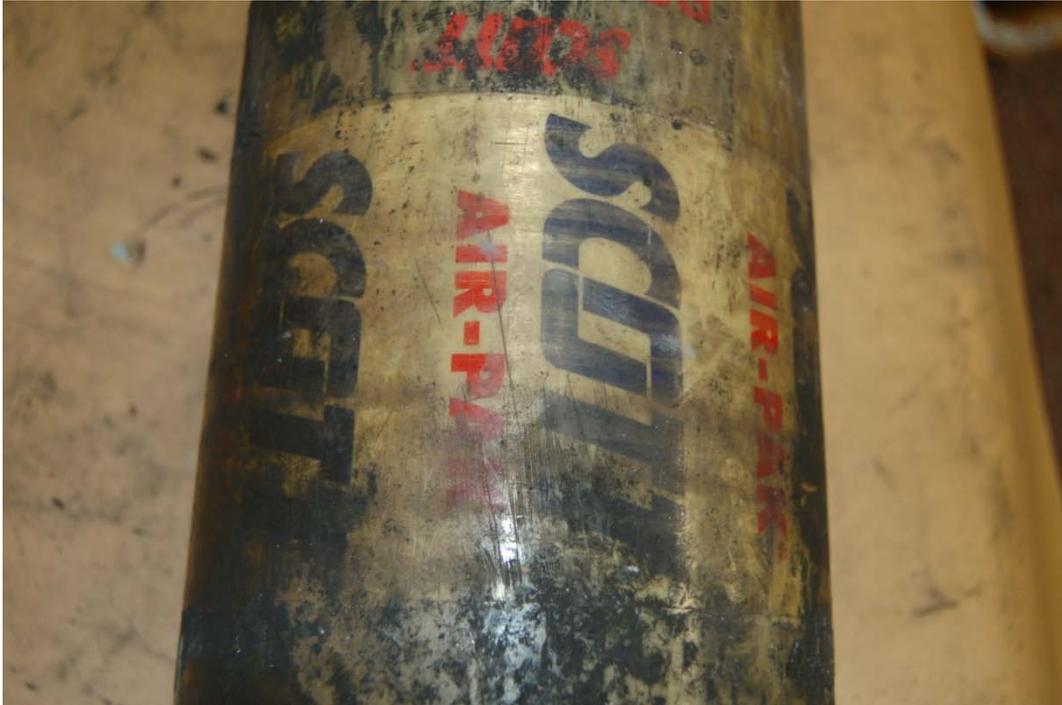
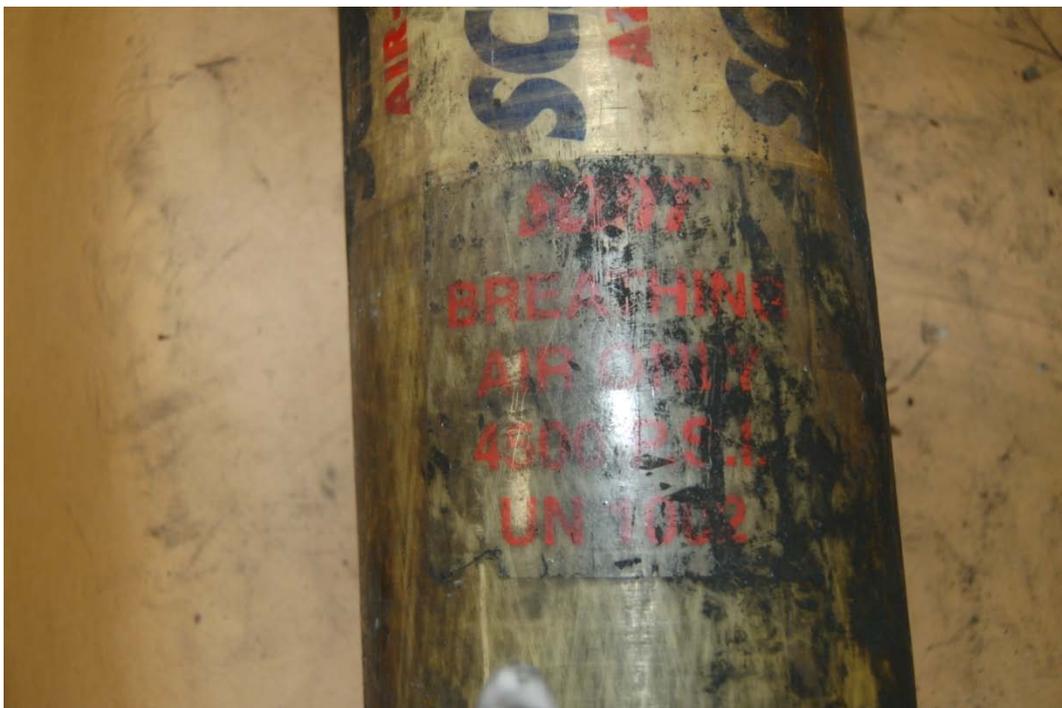
The air cylinder on unit # 1 was so heavily damaged that the manufacturer, date of manufacture, DOT number, and re-test date label were not readable and a cylinder re-test date could not be determined.

- The over-all condition of the assembly is heavily damaged.
- The outer covering of the cylinder is burned and black in color.
- No labels readable except Scott Logo.
- Cylinder gauge unreadable.
- Valve assembly threads clean and undamaged.
- Cylinder valve hand wheel can be turned and valve can be opened and closed.
- Cylinder valve in the closed position when received.
- Rubber bumper on cylinder valve is extensively damaged.

Figure 33 – Unit #1 Cylinder Assembly

Figure 34 – Unit #1 Cylinder Assembly

Figure 35 – Unit #1 Cylinder Valve and Gauge Assembly

Figure 36 – Unit #1 Cylinder Valve Assembly

Figure 37 – Unit #1 Cylinder Markings

Figure 38 – Unit #1 Cylinder Marking
