Status Investigation Report of A
Self-Contained Breathing Apparatus
Submitted by the
Baltimore County Fire Department and Police Department
for the
Lutherville, MD Fire Department,
Lutherville, MD

NIOSH Task Number 17689

April 18, 2011

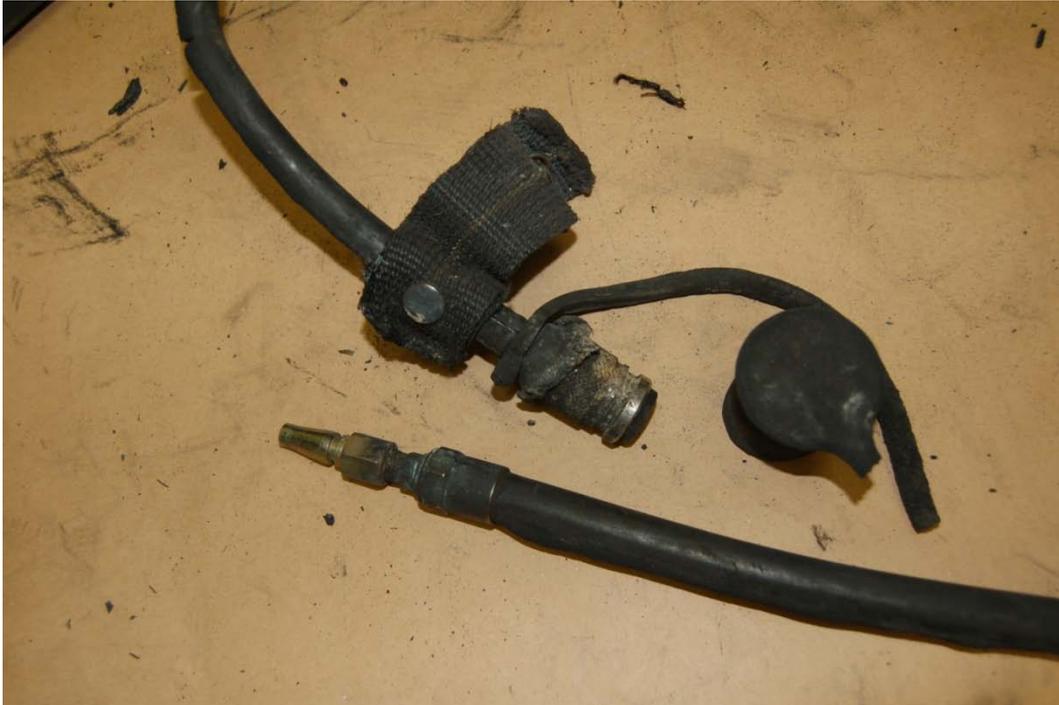
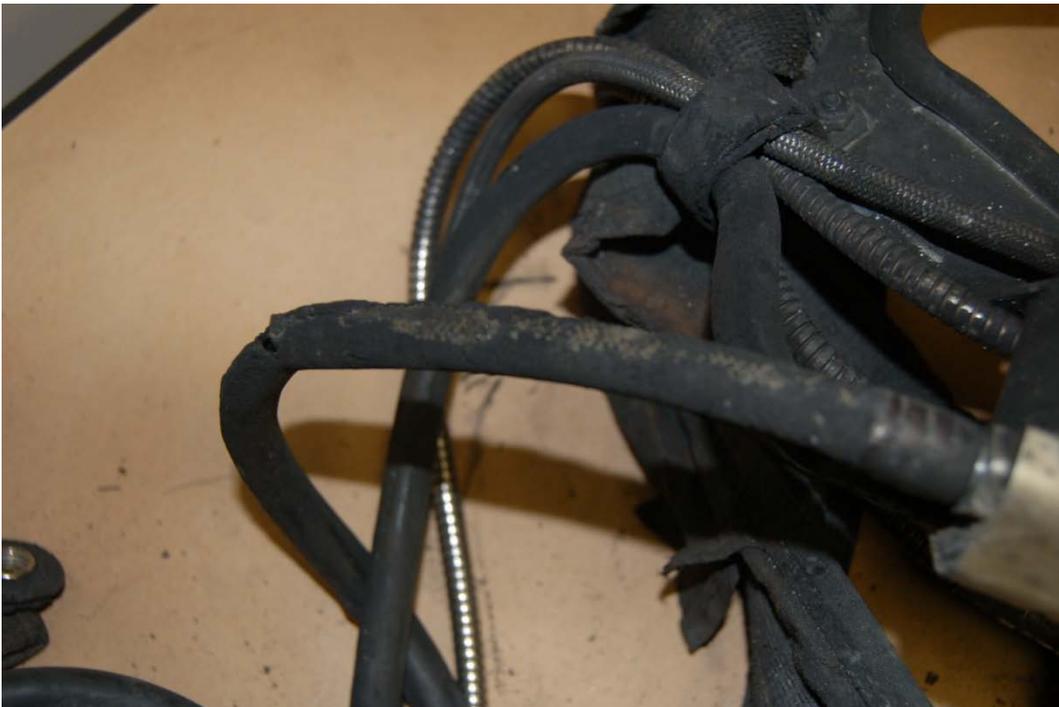
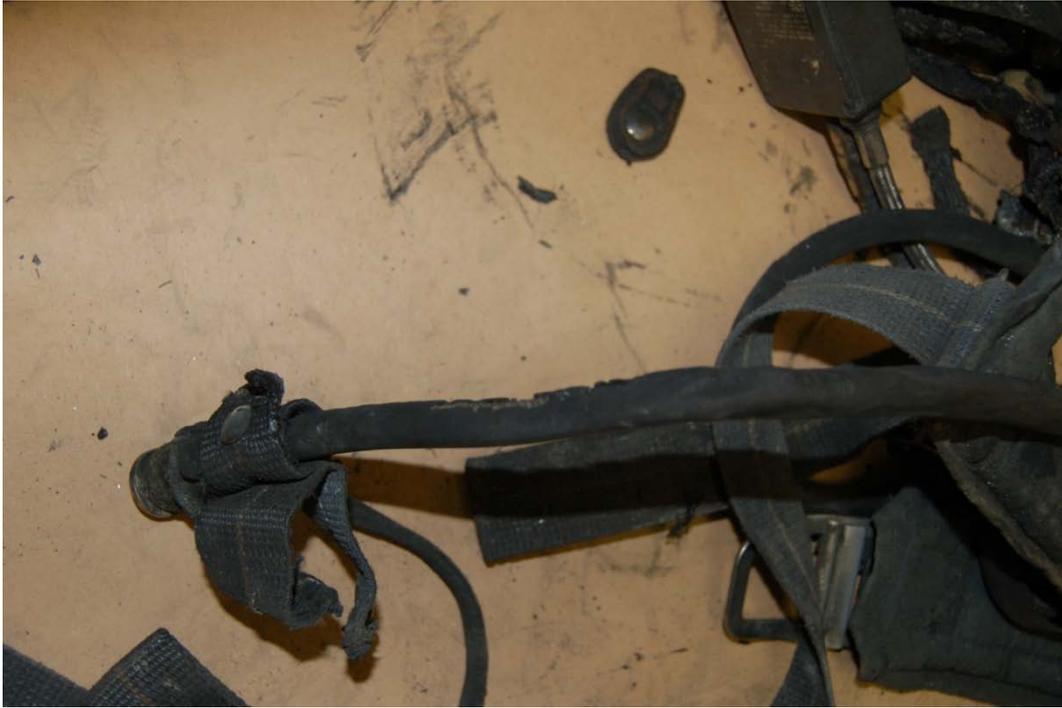
- Condition of Buddy Breather Assembly is extensively damaged.
- As received hose was hanging loose on SCBA.
- No rubber boots were present on the end fittings.
- Male fitting appears relatively clean.
- Female fitting more damaged.
- Hose line in poor condition as the line was burned the entire length.
- Hose line had several holes present.
- The two fittings appeared to function with some effort.

Figure 38 – Unit #1 Buddy Breather Unit

Figure 40 Unit #1 Buddy Breather Hose Damage

Figure 41 – Unit #1 Buddy Breather Hose Damage

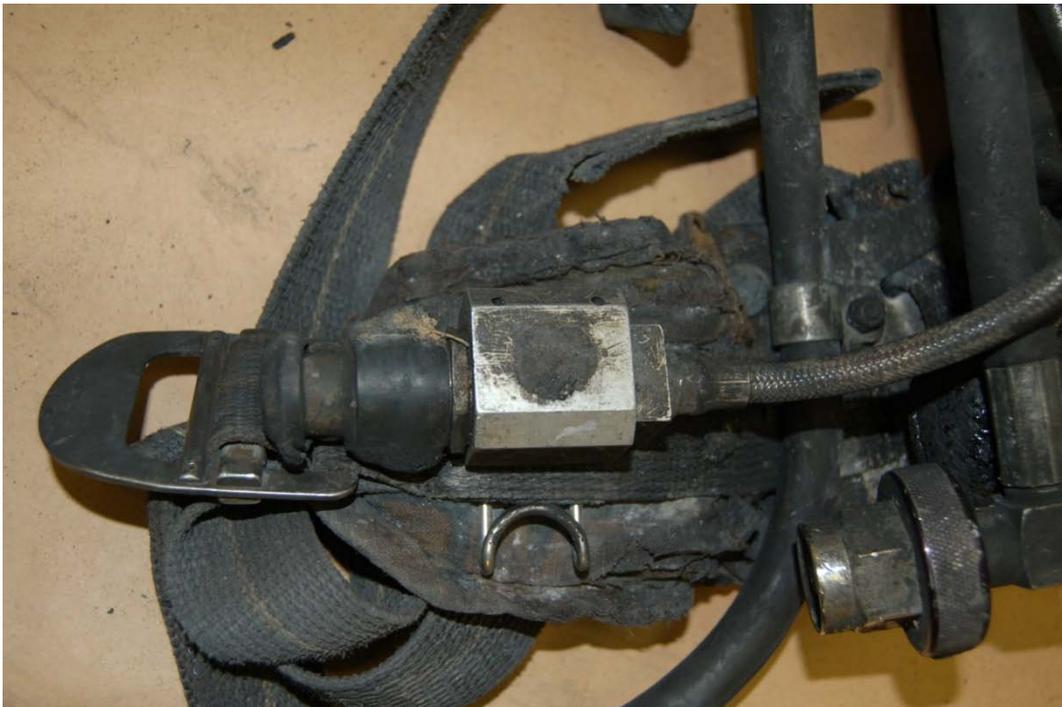
Figure 42 – Unit #1 RIC Fitting, Hose with Boot

- The over-all condition of the assembly is extremely damaged.
- Outer covering of the hose is missing for most of the length, exposing the inner hose.
- Rubber boot present on fitting but extremely damaged and tightly attached.

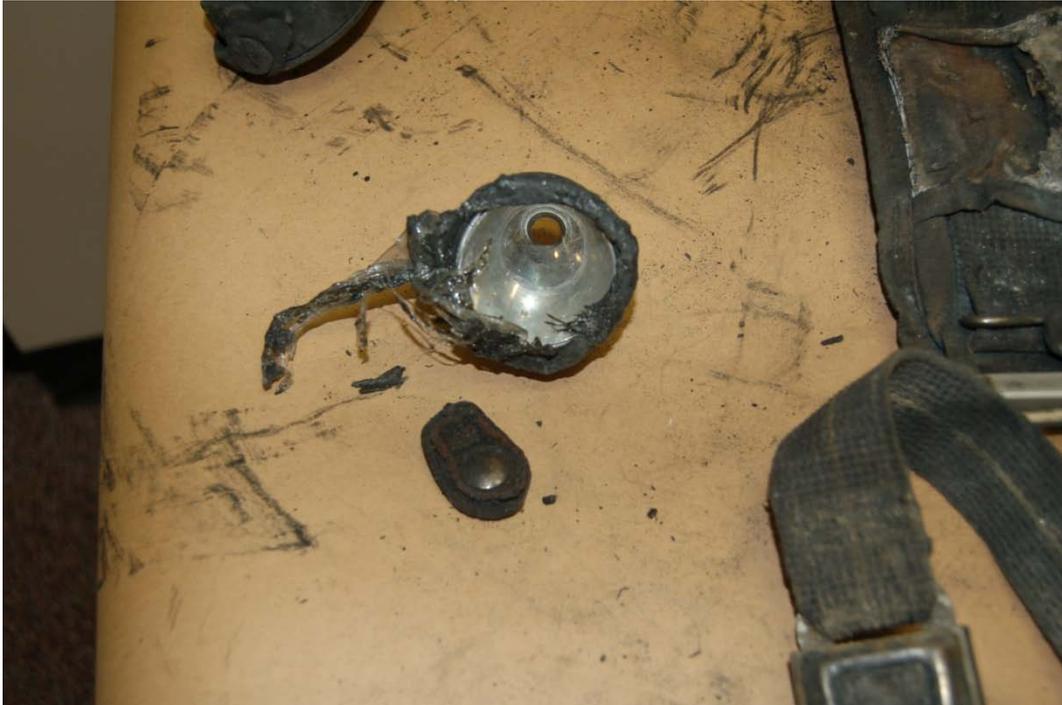
Figure 43 – Unit #1 Flashlight and Snap Components

- Flash light lens and collector assembly showing damage.
- Loose Snap.
