Status Investigation Report of A
Self-Contained Breathing Apparatus
Submitted by the
Baltimore County Fire Department and Police Department
for the
Lutherville, MD Fire Department,
Lutherville, MD

NIOSH Task Number 17689

April 18, 2011

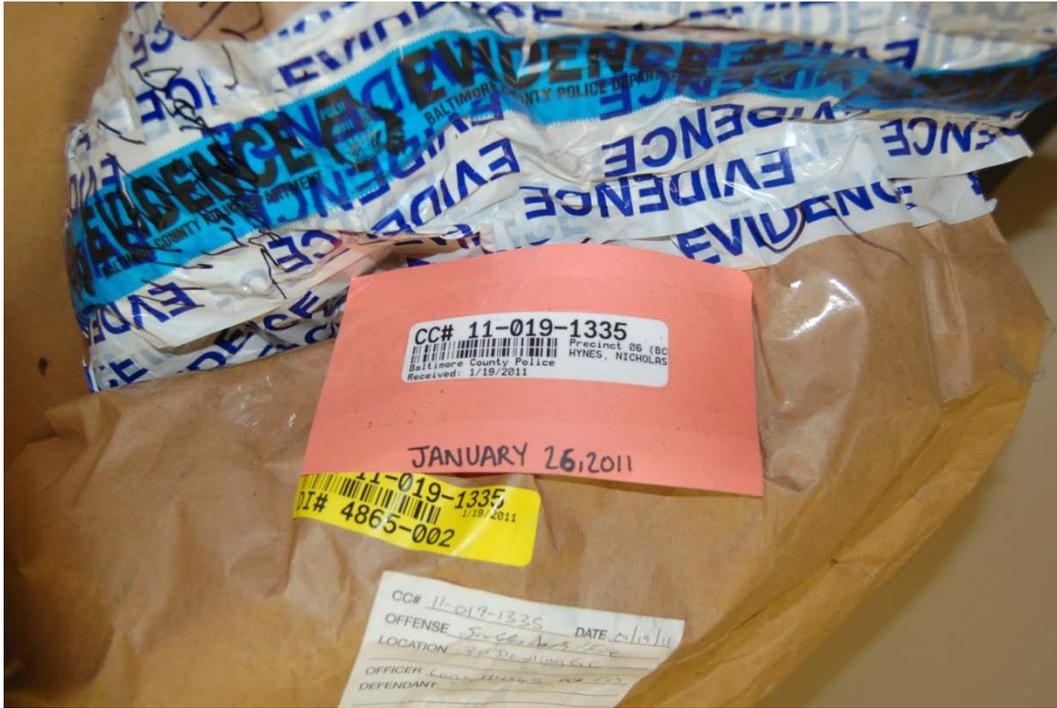
Figure 3 – Unit #1 SCBA Package Evidence Tags

Evidence tags on Bag #1, SCBA: (refer to Figure 3 in Appendix III)

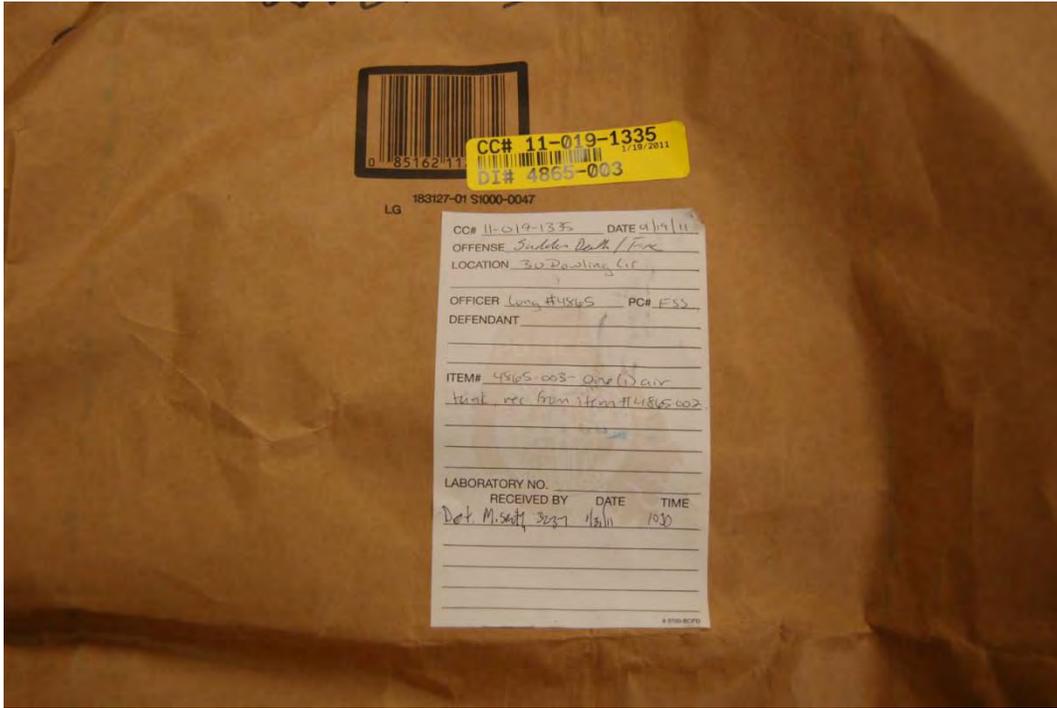
Figure 5 – Unit #1 Cylinder Packaging Evidence Tags

Evidence tags on Bag #2, Cylinder: (refer to Figures 5 and 6 in Appendix III)

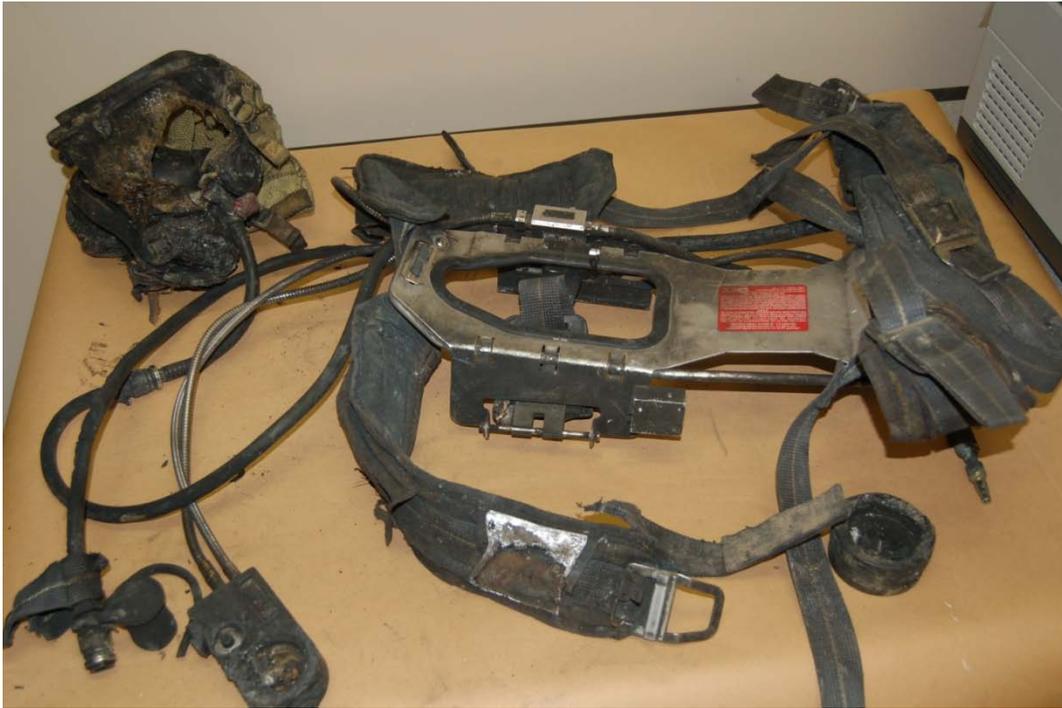
Figure 7 – Unit #1 Without Cylinder

8. Backframe Assembly: (Refer to Figures 7, 23 - 27 in Appendix III):

9. Straps and Buckles: (Refer to Figures 7, 28 - 32 in Appendix III):
