2021 ANNUAL REPORT CONSENT DECREE CIVIL NO: AMD 05-2028  
(Reference DOJ Case No. 90-5-1-1-4402/2)

# **Annual Report**

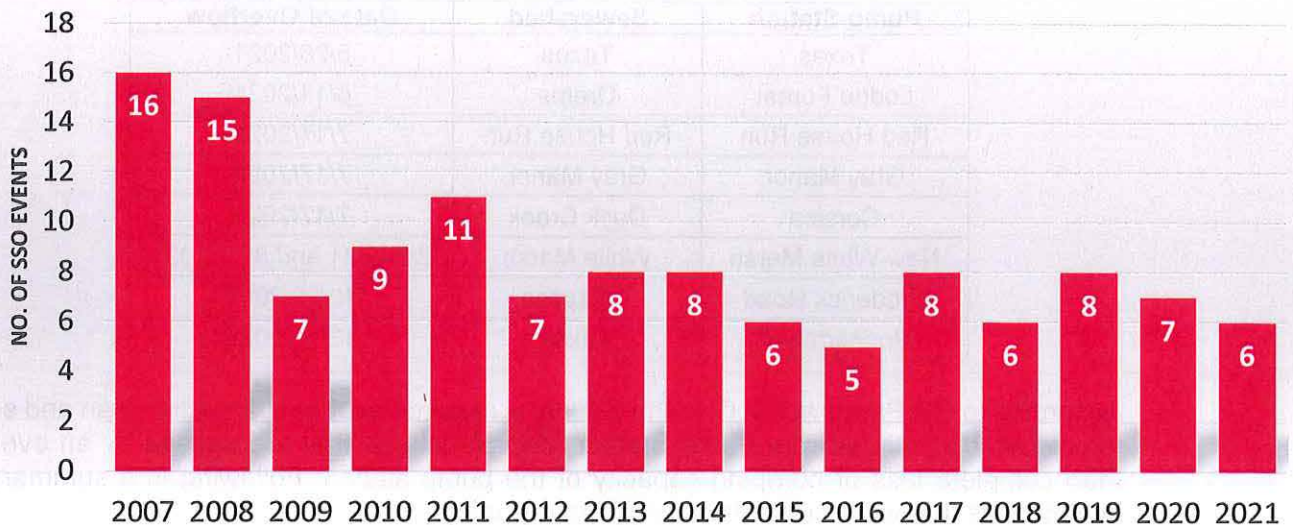
Includes all grease-related SSOs  $\geq$  50 gallons due to grease, grease and rags or grease and roots.

Excludes private SSOs and basement backups.

The graph indicates a 63-percent decrease in the number of reportable FOG-related SSOs between 2007 and 2021. Since 2010, when the County implemented the modified FOG program, the number of reportable FOG-related SSOs has remained relatively stable; however, the County believes that there is an insignificant number of FOG-related SSOs to establish a trend.

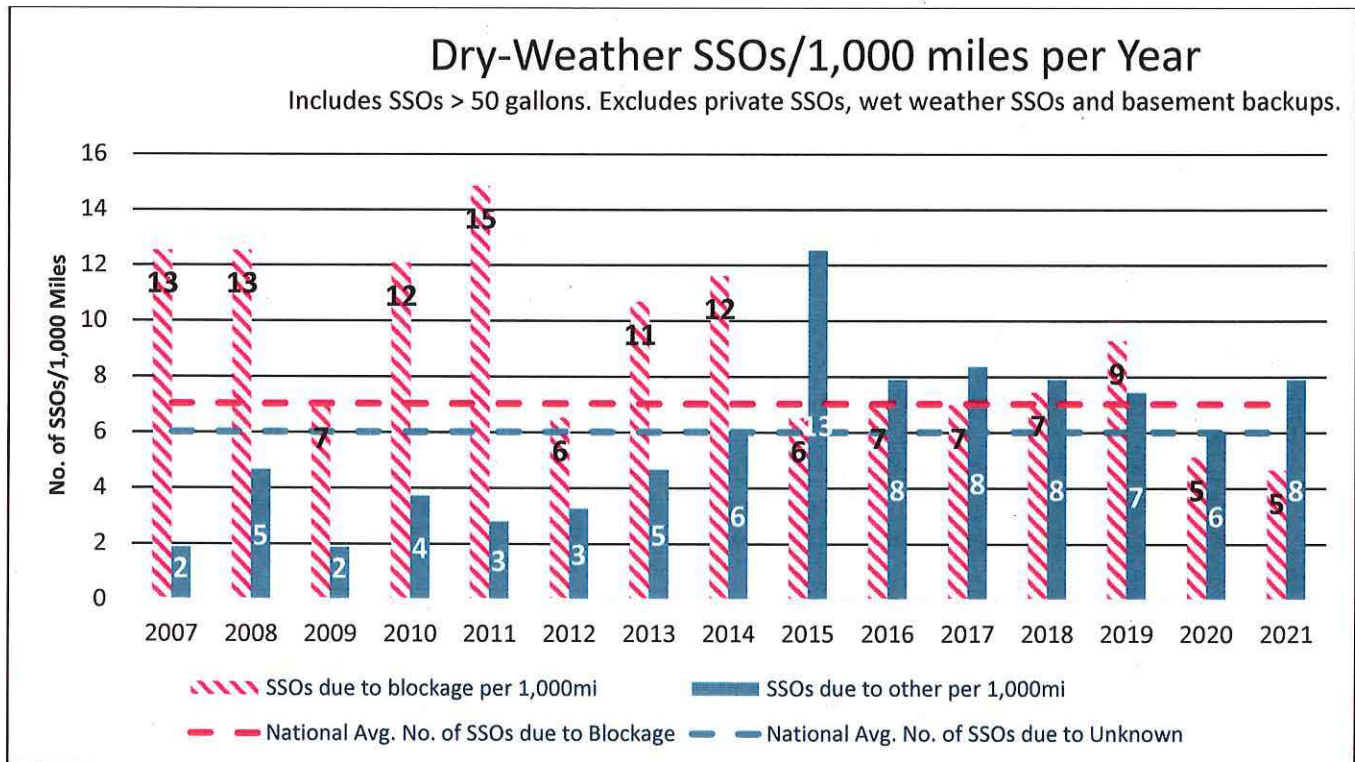
Based on the data available in EPA's report to Congress titled "Impacts and Control on CSOs and SSOs", dated August 2004, there are, on average, approximately 7 dry-weather SSOs due to pipeline blockages per 1,000 miles per year and an additional 6 dry-weather SSOs with unknown causes per 1,000 miles per year. Below is a summary per year of Baltimore County's dry-weather SSOs due to a pipeline blockage.

As shown in the above graph, since 2015, the number of SSOs per year due to roots, grease and debris is approximately equal to the national average; however, in the same time period, the number of SSOs per year due to unknown/other causes, such as broken pipe, vandalism, etc. has increased compared to the prior year (2007-2014) time frame.
